Characterisation of oil-industrial contamination using aerial and thermal images

L. Mucsi

Applied Geoinformatics Laboratory, University of Szeged, Hungary

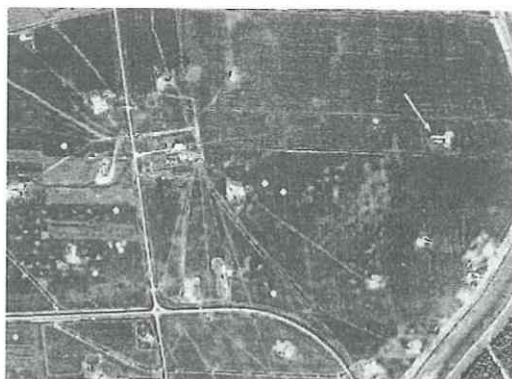
Figure 4. Oil wells on the oil-field in 1981. The white arrow shows to a near-well soil disposal. White circles are the location of the new wells.

The existing geographical co-ordinates of the wells were the geometrical data in GIS, the time of drilling, the depth of the well, and other attribute data were put into the database system. Attribute data selection method was used to preselect the wells with potential near well disposal. The surrounding of the wells was investigated on the aerial photos (1981) and the outline of the discovered (opened or covered) disposal was digitised manually from the screen.

Today there are 513 oil wells on the investigated area and 201 near well soil disposals were mapped according to the above mentioned method.

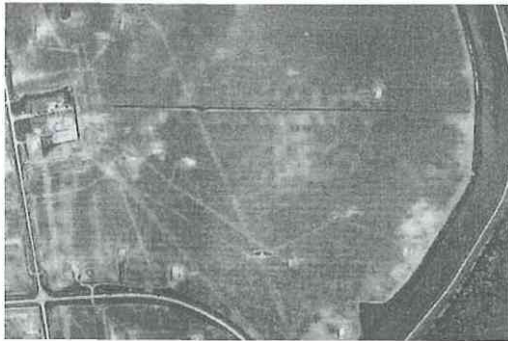
Figure 5. Oil wells on the oil-field on 26th May 1995. Disposal shown on Fig. 4. is covered by soil.

A part of the investigated can be seen again from 1995 in Figure 5. The underground pipeline network can be seen on the originally colour infrared image as bright grey lines because of the disturbed upper soil layer.

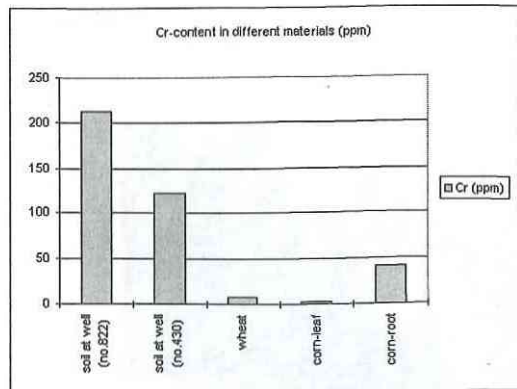
Figure 6. Cr-content of different materials

The surrounding surface of the well are used to cultivated field. In lack of the knowledge underground material different plants were planted on these surfaces. The Cr-content of soil samples and plants can be seen on the Figure 6.

The samples were analysed in the soil chemical laboratory in the Department of Physical Geography, University of Szeged.
